**CRASHWORTHINESS: AN ILLUSTRATED COMMENTARY ON OCCUPANT
SURVIVAL IN GENERAL AVIATION ACCIDENTS**

Civil Aeromedical Institute
Federal Aviation Administration
Oklahoma City, Oklahoma

1. Report No. FAA-AM-83-8	2. Government Accession No. AD-A130 198	3. Recipient's Catalog No.	
4. Title and Subtitle CRASHWORTHINESS: AN ILLUSTRATED COMMENTARY ON OCCUPANT SURVIVAL IN GENERAL AVIATION ACCIDENTS		5. Report Date APRIL 1983

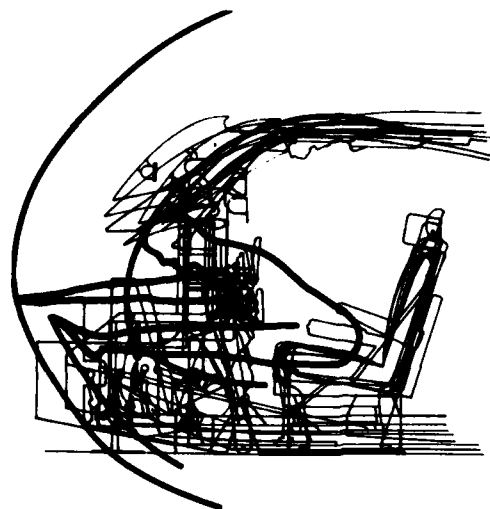
Figure 2

When a seatbelt is worn, the belt will hold the pelvis and keep the lower torso from traveling forward (Figure 2). The upper torso, head, arms, and legs will continue their forward motion. These flailing body parts may strike the windscreen, instrument panel, fuselage structural parts, control wheels, rudder pedals, and other components. This subjects the occupants to impact force of high magnitude and can cause severe or fatal injuries. The head is frequently stopped by the instrument panel, causing fractures of the skull and facial bones, and lacerations of the brain. If the head is stopped by impact with the interior, but the torso continues movement, fracture or dislocation of the neck can occur, perhaps with spinal cord involvement. The chest may impinge upon the control wheel or yoke, causing crushing or penetrating injuries. The forward flexion of the upper torso can be reduced to a large degree by the use of an upper torso restraint--a shoulder harness. The legs and feet flail forward into the rudder pedals or underneath the instrument panel. The vertical component of the deceleration causes downloading on the seat which may fail the seat/floor attachments, the seat legs or the seat pan. The floor may deform and cause seat attachments to fail. In crash injury studies, it is important that the direction of the impact and the magnitude and directions of decelerations experienced by the occupants be investigated, reported, and analyzed to assess the degree of protection provided by an aircraft and its restraint systems.

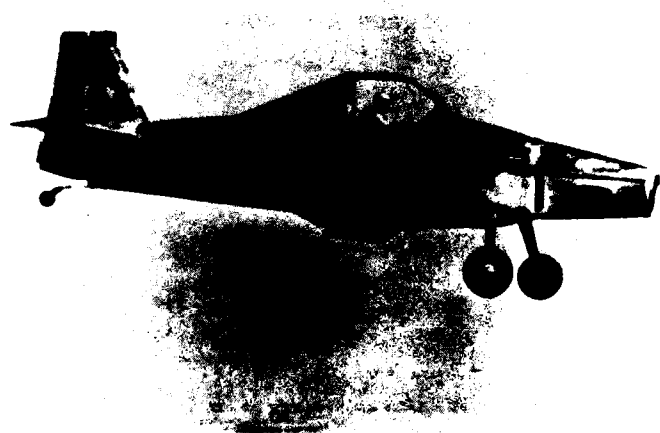
Figure 10

Crashworthiness principles, as advocated by De Haven and Hasbrook, were incorporated in the AG-1 prototype agricultural aircraft designed and built in 1950 at Texas A&M University by Weick (Figure 10). In this aircraft the pilot sat high above and behind the wing. There was a hopper between the pilot and the engine. The structural members of the cockpit were strong--a sturdy outer package. The pilot was restrained by a lapbelt and a double strap shoulder harness. He wore a helmet and there was a large roll of aluminum above the low positioned instrument panel--to distribute the force of any impact should the pilot's head move forward and contact it during a crash.

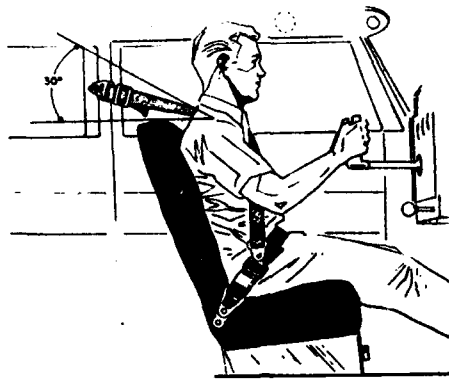
Figure 13

The most economical and effective way to improve crashworthiness of general aviation aircraft is to provide a strong restraint system for each occupant. In its simplest form this includes a lapbelt fit properly to the pelvis, a shoulder harness (preferably double strap) and a seat that will yield but not break (Figure 13).

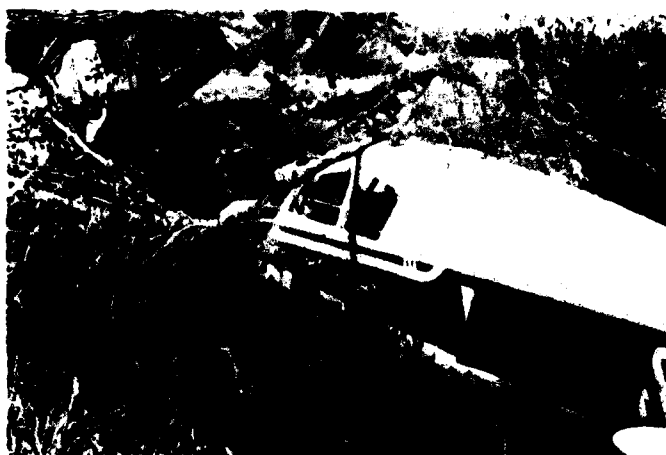
Figure 16

This aircraft (Figure 16) struck relatively level ground and some willow trees. The pilot got out, walked several miles and was then taken to a hospital emergency room. His only injury was a bruised chest.

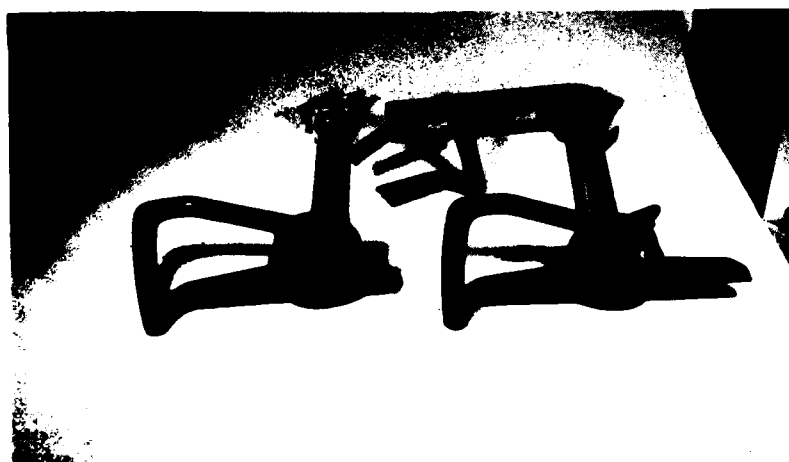
When the control wheels in Figure 18 were examined, two different breaking patterns were noted. The one on the left (pilot's) broke close to the hub as the pilot jackknifed forward and hit the wheel. This resulted in blunt trauma to his chest. The right seat occupant, also jackknifed forward, striking the yoke with his chest and the yoke broke in such a way that a sharp spike remained protruding from the hub. Microscopic examination of a brown film on this spike showed it contained red blood cells, fragments of skin, and pieces of muscle. This "spike" portion of the control wheel

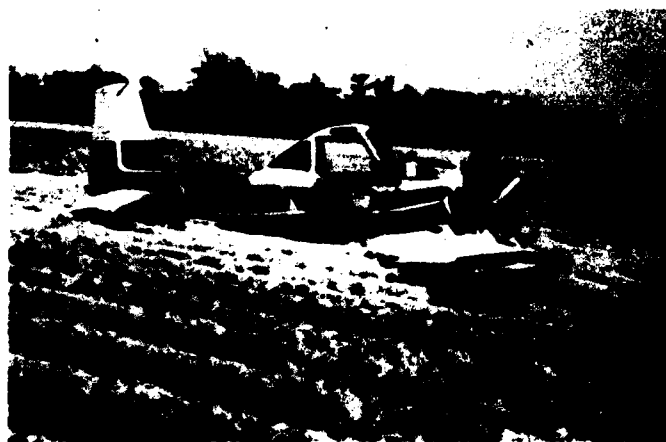
The agricultural aircraft in Figure 19 ran out of fuel, stalled, and struck the ground in a 45° nosedown attitude. The plowed ground tended to attenuate the impact forces. The pilot was provided additional stopping distance by structural crushing, which ended with the engine displaced aft and somewhat above the hopper. Although the pilot had conspicuous shoulder harness and lapbelt contusions and abrasions, he sustained minor injuries.

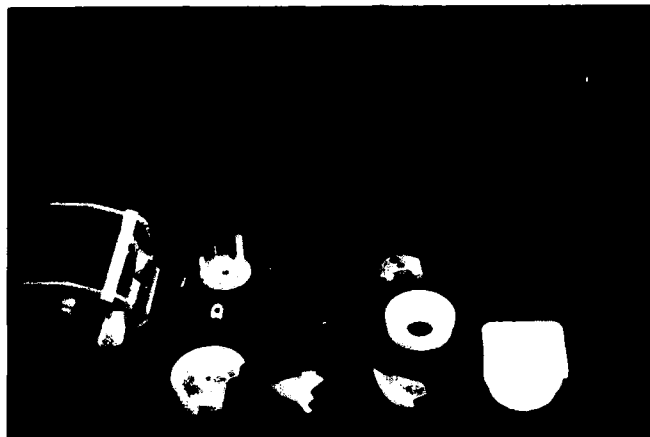
For example, Figure 24 shows an inertia reel that failed in a survivable accident. The pilot was severely injured but survived.

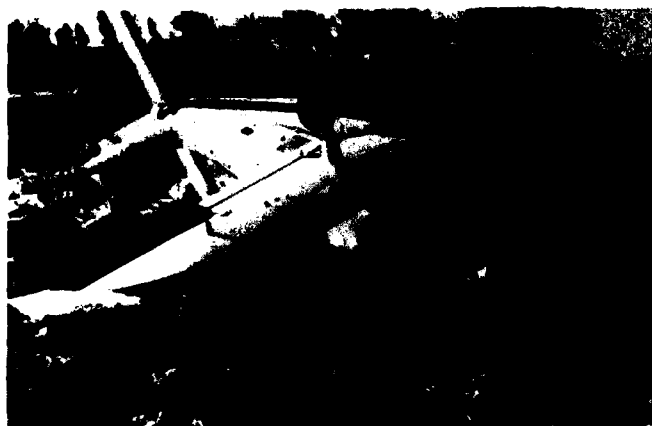
Figure 25

In the accident shown in Figure 25, the impact force was somewhat from the right. The woman in the right front seat was said to have been

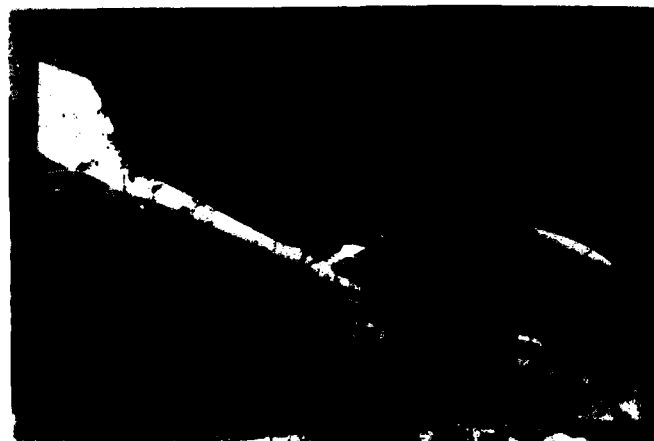
The aircraft shown in Figure 29 had power failure on takeoff and crashed into a dirt bank at relatively low velocity. One of the two 17-year-olds in the rear seat was uninjured. The other had unexpected internal injuries. Unrestrained objects in the baggage area struck the back of the seat, driving it forward and causing the lapbelt to compress the occupant's abdomen. The right front seat occupant, who was not using a shoulder harness, received a fracture of the mandible.

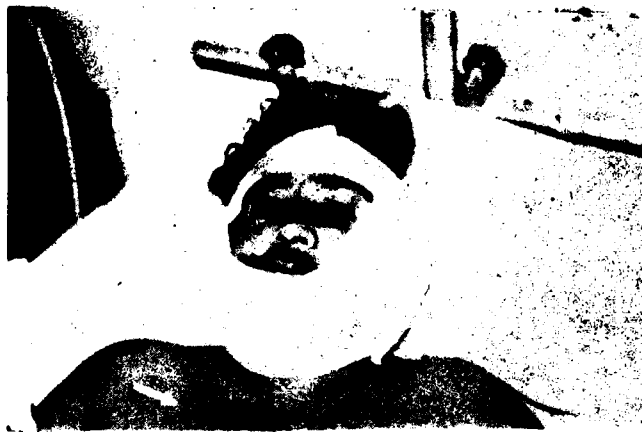
Figure 30

This pilot's injuries illustrate the value of the shoulder harness (Figure 30). The bandage on the head covers a large laceration. Notice marks on his upper chest made when he struck the control wheel. He was wearing the shoulder harness and lapbelt.

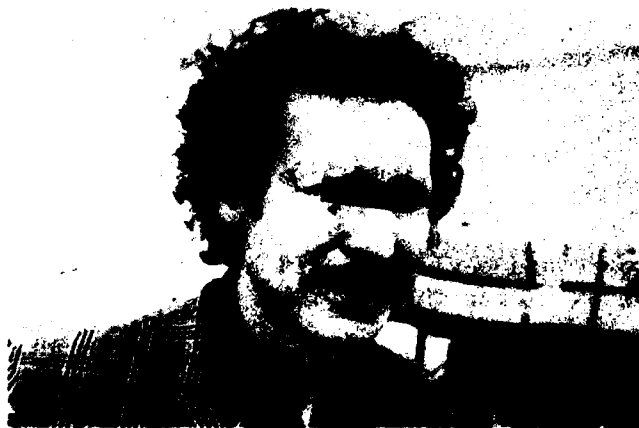
Figure 34

The right seat passenger (shown in Figure 34) had a small cut above his eye. However, the pilot was found on top of the roof, dead from a crushed skull. Why was there this discrepancy in injuries to the occupants? Investigators of accidents in which there are similar disparities in injuries should satisfy themselves as to the sources of these differences.

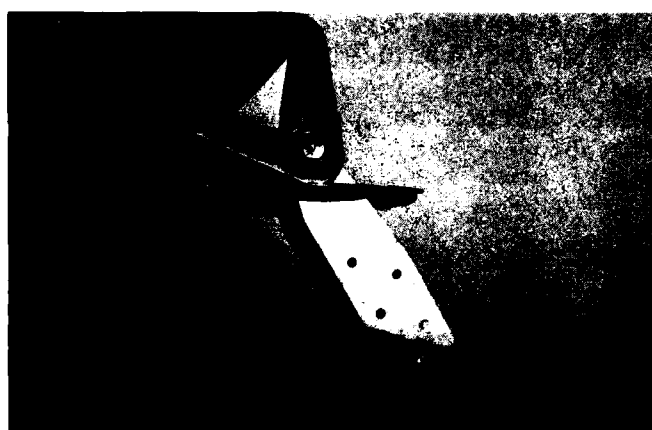
Figure 36

Investigation showed (as in Figure 36) that the lapbelt attachment had pulled free from its anchorage. During impact, sufficient force was applied to the lapbelt (there were no shoulder harnesses) to break its attachment and the pilot was thrown from the aircraft onto the roof of the building. The resulting fatal head injuries were caused by the secondary impact.

Investigators should examine such a lapbelt attachment closely, perhaps even under magnification, to estimate the degree of deformity of each hole to determine whether or not all the rivets or bolts had been in place. Did the restraint fail due to poor manufacture? Was there intrinsic weakness in the materials or attachment configuration?

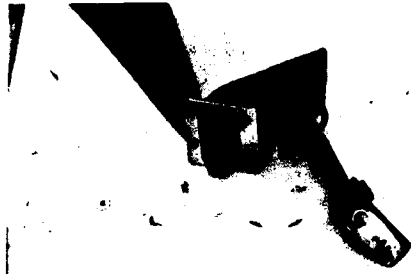
Figure 39

The failed lapbelt attachment is shown in more detail in Figure 39. Note that it was pulled out from its anchorage. The pilot was dead from head and neck injuries. An investigator should ask himself, "Is it reasonable to expect the lapbelt to hold in such an impact?" The engineer should ask himself, "How can the system be strengthened with respect to all the other technical considerations that go into the design and manufacture of an aircraft?" Since this accident, the manufacturer has strengthened the lapbelt attachment in this aircraft model.

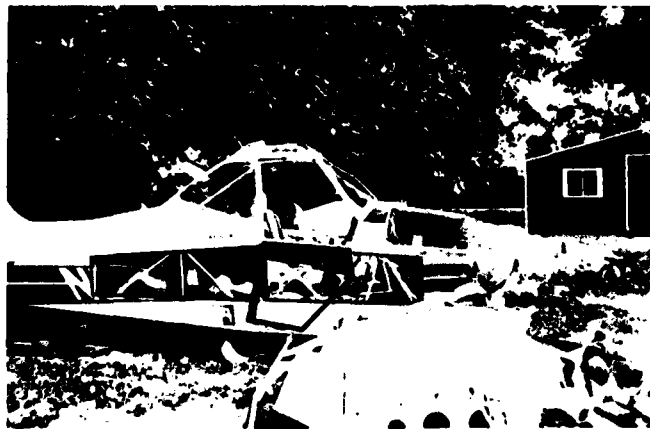
Figure 40

A problem with restraint attachments is illustrated by the accident in Figure 40. The engine was torn off but the cabin structure remained intact.

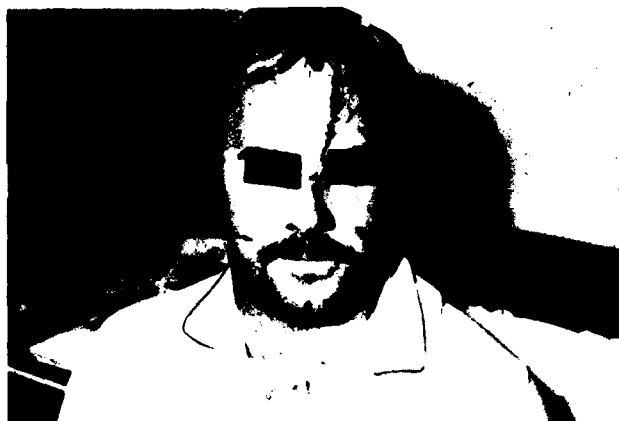
Figure 41

The pilot (Figure 41) sustained a long vertical laceration on his forehead. Accident investigators found a corresponding vertical cleavage in his helmet. By absorbing most of the energy of the head impact, the helmet probably saved this pilot's life. One experienced in crash injury correlation would seek to explain the unusual injury pattern.

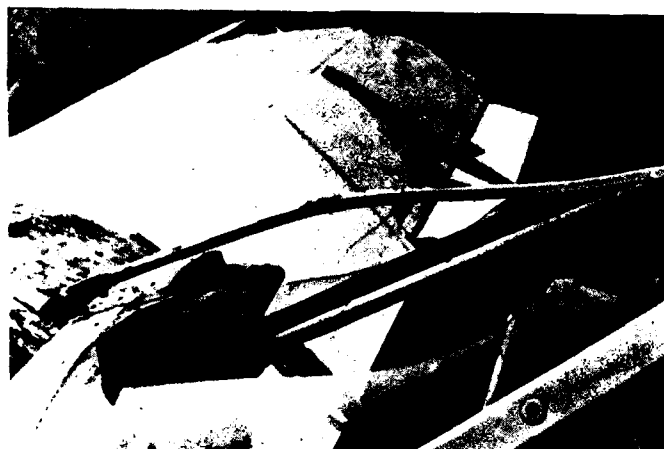
Figure 42

Examination of the aircraft revealed that the windshield was broken and that the vertical wire cutter bar in front of the windshield was bent forward (Figure 42). Here, then, was the most probable explanation for the vertical cleavage in the helmet and corresponding laceration of the pilot's scalp--the pilot had been thrown forward, striking the wire cutter bar with his head. There was also a broad concavity in the instrument panel showing that it had been struck by the pilot's chest. Analysis provided the crash injury correlation but the question remained, "Since the pilot wore a double shoulder harness and lapbelt, why did he travel far enough forward during the crash to strike forward structures in such a 'mild' crash?"

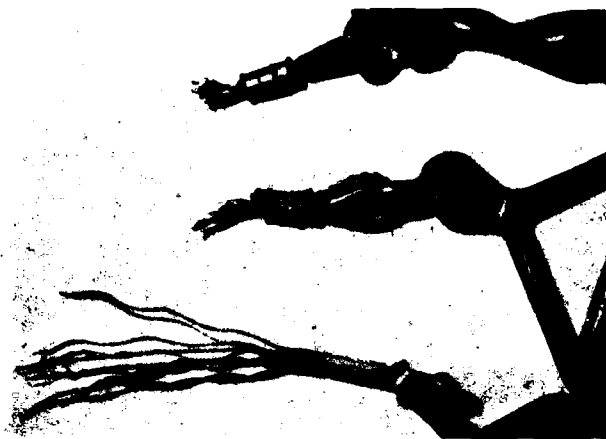
Figure 43

The answer appeared from inspection of the restraint system (Figure 43). The lapbelt ends were attached to wire cables. The cables extended through a bulkhead behind the pilot and were attached to the rigid aircraft frame. The shoulder harness cable led over a pulley behind the pilot's seat and was attached to an inertia reel. The photograph shows all three cables broken. The lapbelt cables had wires which had broken by repeated bending during normal use. The shoulder harness cable wires had broken in a similar manner. Other aircraft of the same model were found to have cables with broken wires. The manufacturer, subsequently, changed the cables and the configuration of the attachments to prevent weakening of the restraint system.

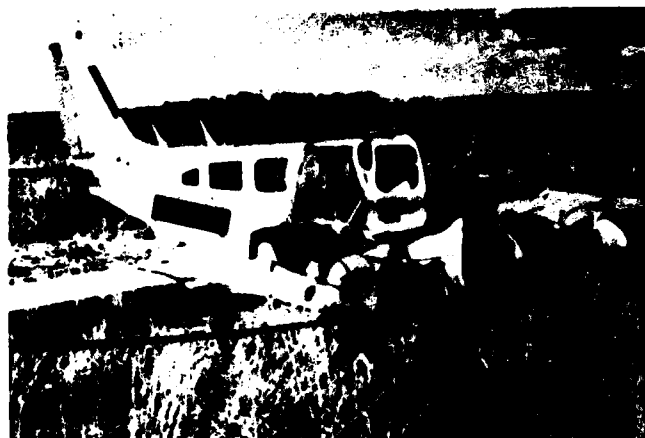
The aircraft in Figure 46 failed to become airborne and during takeoff struck a levee. The deceleration primarily was in a forward direction and one would expect the front seat occupants to receive the most severe injuries. On the contrary, the two occupants in the rear seats sustained fatal injuries and the front seat occupants, who were not using shoulder straps, had severe head injuries but survived.

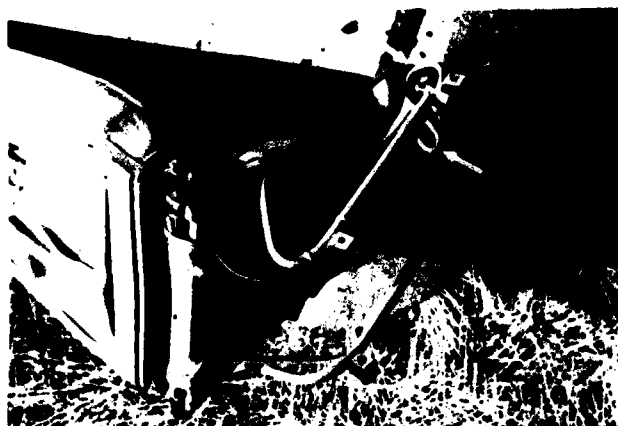
Figure 47

One of the front seats is shown in Figure 47. It is of the tubular ductile metal design previously described and it bent in a desirable manner. Although this was primarily a forward loading accident, the bending of the seat frame indicates there was significant downloading. An additional feature was that the outboard seat support was of smaller diameter, and bent more readily than the inboard support. The differential bending (lateral displacement) could cause the occupant to roll into, rather than out of, the diagonal shoulder harness.

However, it also could cause lateral deflection of the vertebral column and increase injury. Differential lateral bending of seat supports should not be necessary in a properly designed complete restraint system.

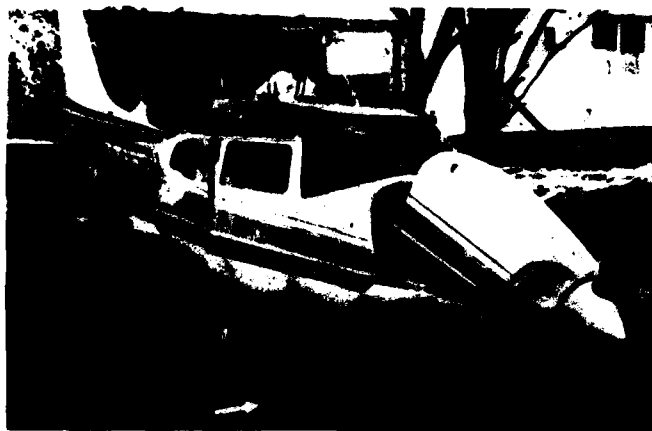
Investigators noted that the six occupants of the aircraft shown in Figure 48 received injuries out of proportion to the impact and severity of damage to the fuselage. They also found that the cast alloy supports of each seat had fractured (Figure 49).

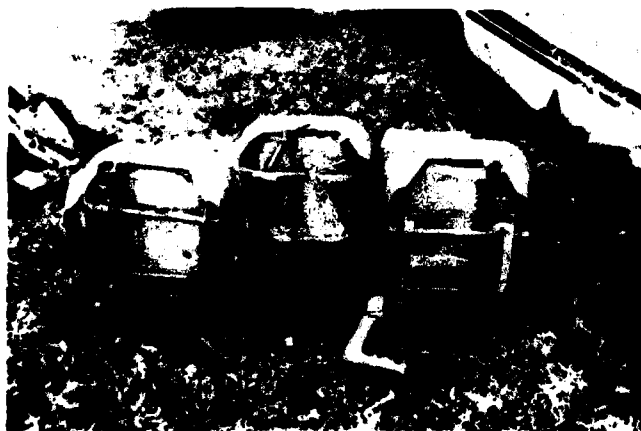
Figure 49

This type of failure occurs suddenly and the occupant is subjected to greater peak loading during secondary impact with the cabin floor or other structures.

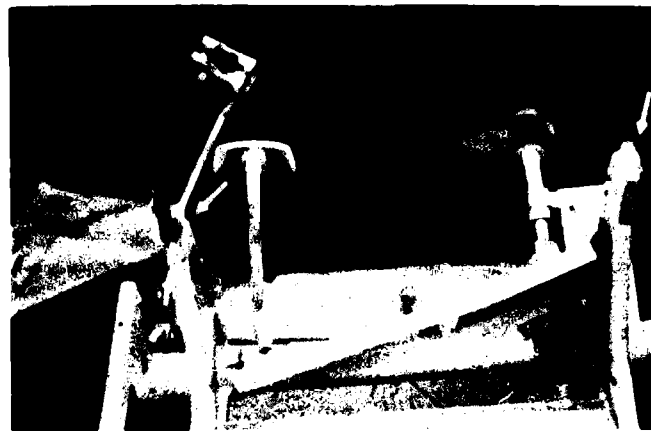
Figure 51

Similarly, loading and twisting of the attachment of the seat to the track can cause the brittle metal to fail (Figure 51) so that the seat and its occupant are free to flail about in the cabin.

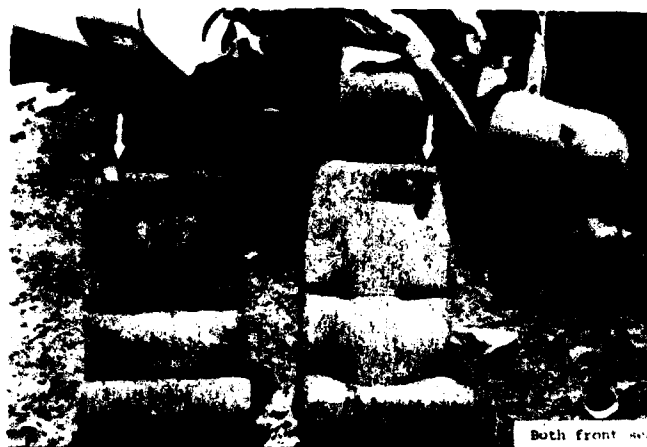
Figure 52 shows a seat with the shoulder harness leading through the seat back and attaching to an inertia reel at the bottom of the seat back. For full protection during an impact this seat back must not fold forward and the seat suspension must bear the occupant loading into the shoulder harness.

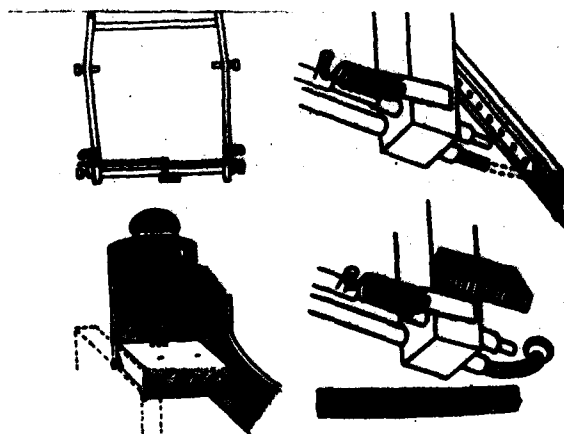
Figure 53

In addition, this particular restraint-seat design (Figure 53) is complicated by the suspension of the seat on axles with rollers in channels on the sidewall and center pedestal as depicted. The integrity of the seat and the restraint system depends on these axles and side channels bearing the crash loads. During an impact an occupant's loading

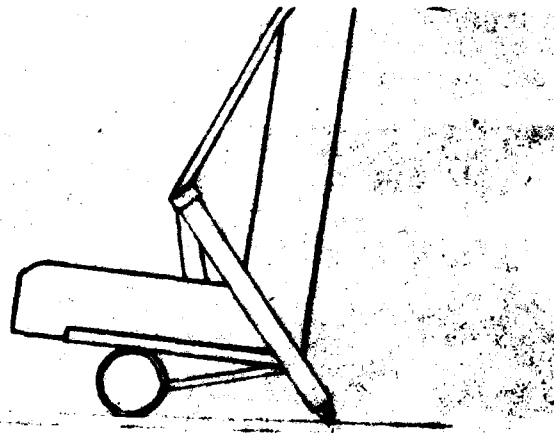
Figure 57 portrays the seat installation. The seat cushion is composed of about 3 inches of soft foam-rubber-like material and sits on a seat pan of plywood. The seat is mounted by metal tracks right on top of the main spar. What degree of protection is afforded by such an arrangement? In an accident, the downward moving lower torso "bottoms out" on the plywood and on the rigid metal tube. The impact force is transmitted directly to the pelvis, spine, and internal parts of the body. Such a configuration provides little or no attenuation of vertical forces.

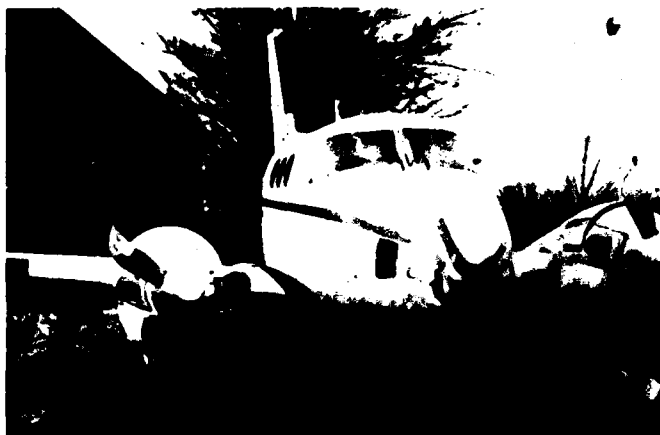
The aircraft shown in Figure 58 landed long and ran off the end of the runway. The structure remained intact and one would expect that the impact was relatively mild, which it was; the pilot was uninjured, three of the four other occupants had only minor injuries.

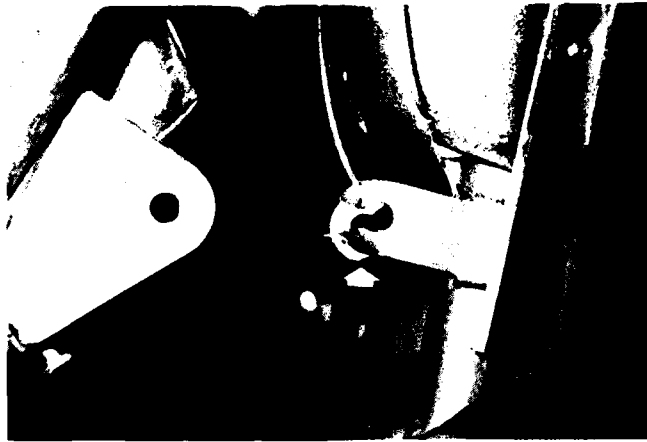
Figure 61

During the deceleration, the upright seat backs were apparently overloaded by the weight of the occupants and failed where the seat back attached to the seat pan (Figure 61). Note the torn hinge metal where the back was attached. Because of this failure, the two occupants slid forward (toward the front of the aircraft) from under their belts and sustained fatal neck injuries in secondary impacts. The lapbelts at the other seats (forward facing) kept the occupants in place. This accident illustrates the differences in occupant dynamics and the need for careful engineering design when aft facing seats are used.
